a living river

CHARTING THE HEALTH OF THE UPPER SANTA CRUZ RIVER
2008 Water Year

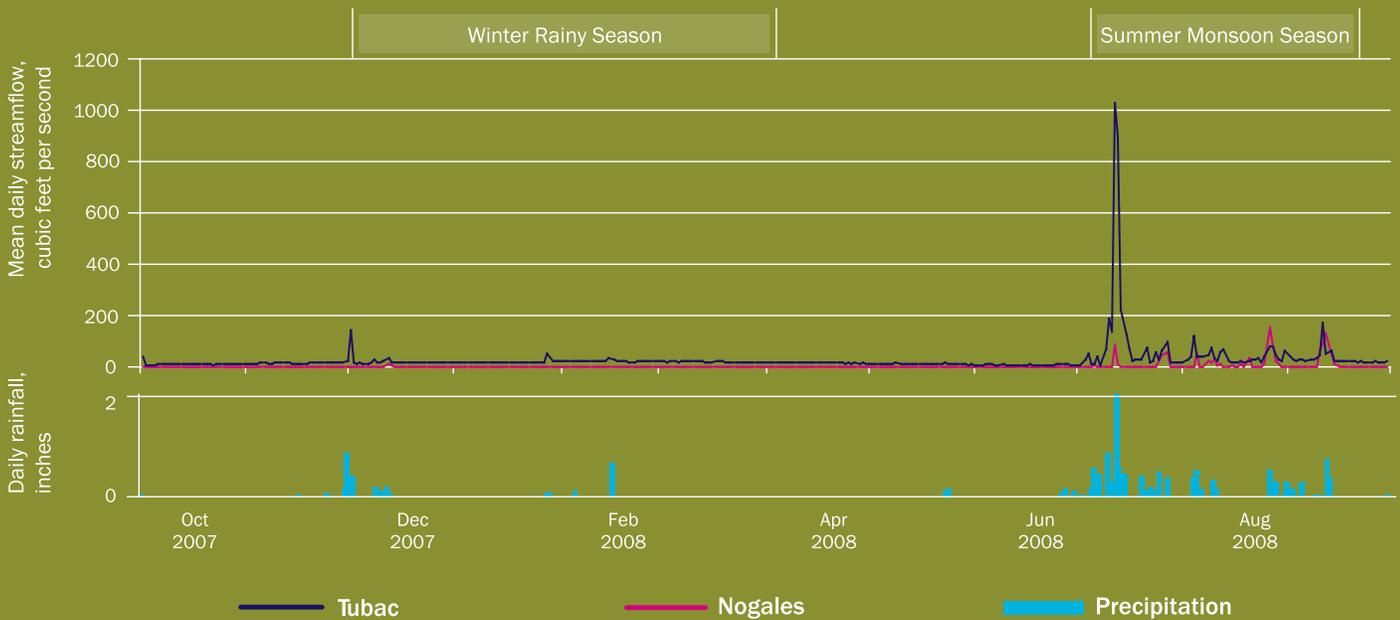
Data sources: USGS station 09481740 and station 09480500 and National Weather Service station KOLS at Nogales International Airport

The U.S. Geological Survey (USGS) measures streamflow, the volume of water flowing past a fixed point for a fixed unit of time (also called discharge), with gages near Nogales, AZ and at Tubac, AZ. The 2008 daily discharge rates are characteristic for the Upper Santa Cruz River at the stream gages.

- Mean daily discharge averaged 3 cubic feet per second (cfs) near Nogales and just under 28 cfs at Tubac.
- Mean daily discharge peaked at 157 cfs on August 26, 2008 near Nogales and at 1,030 cfs on July 12, 2008 at Tubac.

- During the 2008 water year, the station recorded 15.96 inches of rain.
- Just over 2 inches of rain fell during the winter rainy season.
- The summer monsoon brought nearly 12 inches of rain.
- On July 11, 2008 over 2 inches of rain fell in Nogales, AZ. This caused the high river flows at Tubac on July 12, 2008.
- Between August 25 and 26, 2008, 0.85 inches of rain fell in Nogales, AZ. This caused the high river flows near Nogales, AZ on August 26, 2008.

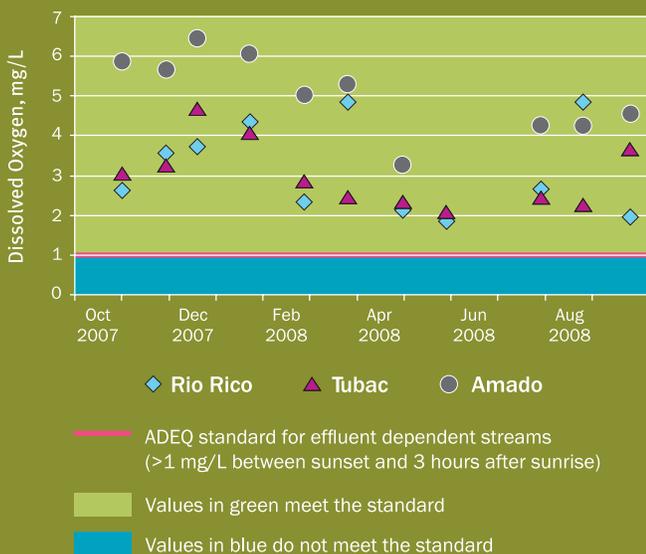
DISSOLVED OXYGEN

Dissolved oxygen was measured between sunset and 3 hours after sunrise a total of 32 times. All of the 32 samples met the standard (100% attainment).

- Rio Rico: 11 of the 11 samples met the standard (100% attainment).
- Tubac: 11 of the 11 samples met the standard (100% attainment).
- Amado: 10 of the 10 samples met the standard (100% attainment).

Data source: Friends of the Santa Cruz River

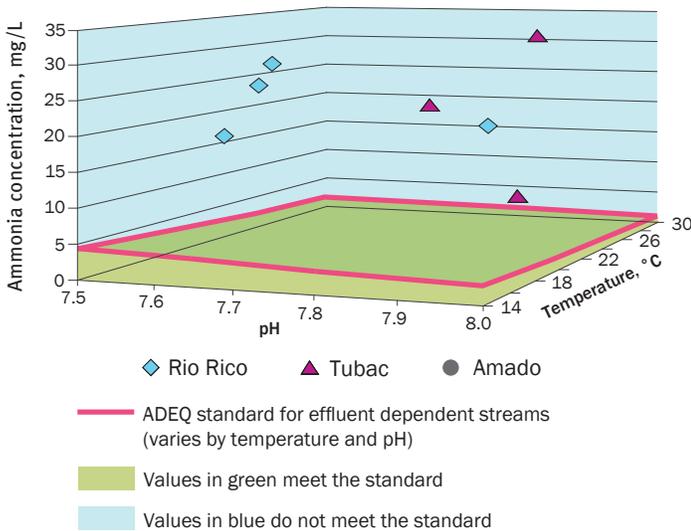
AMMONIA

Ammonia was monitored a total of seven times. Overall, the ADEQ standard was met zero out of the seven times (0% standard attainment).

- Rio Rico: Zero of the four samples met the standard (0% attainment).
- Tubac: Zero of the three samples met the standard (0% attainment).
- Amado: No samples were collected.

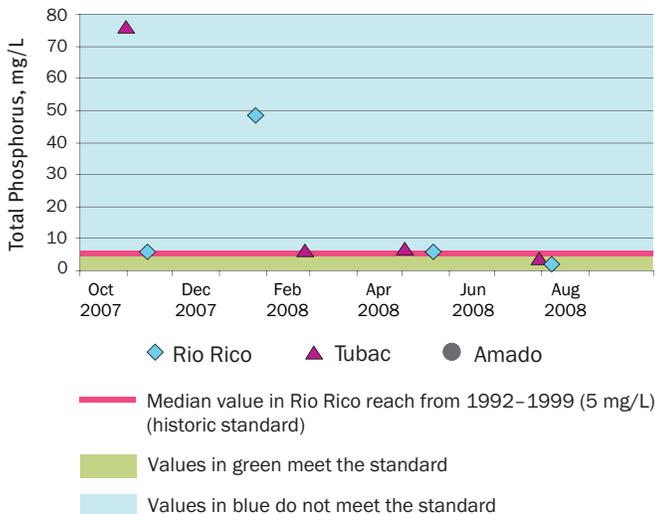
TOTAL PHOSPHORUS

Phosphorus was monitored a total of eight times. Overall, the historic standard was met two out of the eight times (25% standard attainment).

- Rio Rico: One of the four samples met the historic standard (25% attainment).
- Tubac: One of the four samples met the historic standard (25% attainment).
- Amado: Phosphorus was not monitored.

Data sources for charts on page 13: Friends of Santa Cruz River and National Park Service (NPS) Sonoran Desert Network

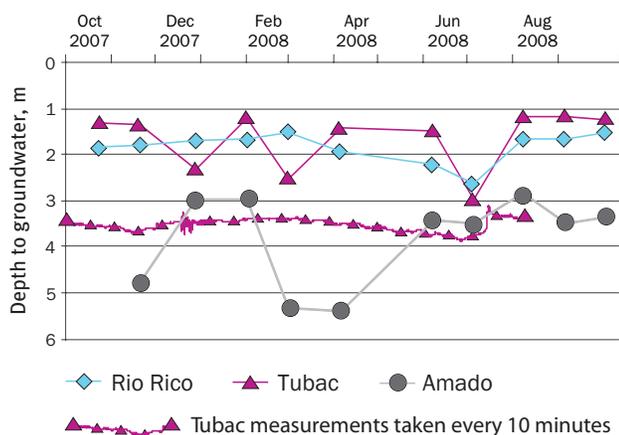
Groundwater variability

The Arizona Department of Water Resources and the National Park Service measured depth to groundwater throughout the 2008 water year at four wells within the floodplain. A chart showing the variability in depth to groundwater is shown on the following page. Groundwater declines from January to June 2008 are listed below.

The following legend corresponds to well monitoring, shown right (page 19).

Data sources: Arizona Department of Water Resources and NPS Sonoran Desert Network

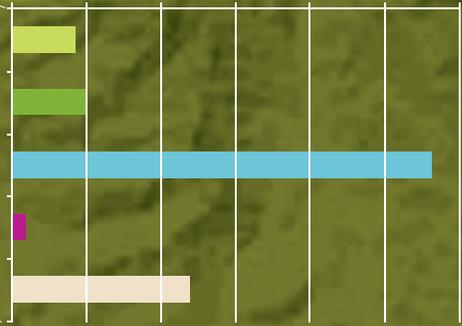
Amado Reach

Overall, nearly 2,600 acres (38 percent) of the area within the 100-year floodplain were dominated by cottonwoods and mesquites, nearly 500 acres (8 percent) were used for human infrastructure, and 1,600 acres (24 percent) were used for crops or pastures. The Tubac reach has the largest percentage of area dominated by cottonwoods (28 percent) compared to the Rio Rico (13 percent) and Amado (8 percent) reaches.

- Cottonwood Forests & Woodlands
- Mesquite Forests & Woodlands
- Other Vegetation
- Human Infrastructure
- Agriculture & Pasture

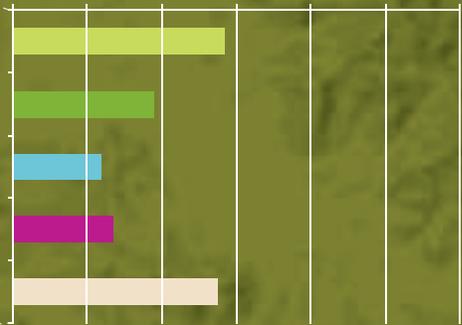
Tubac Reach

- Cottonwood Forests & Woodlands
- Mesquite Forests & Woodlands
- Other Vegetation
- Human Infrastructure
- Agriculture & Pasture

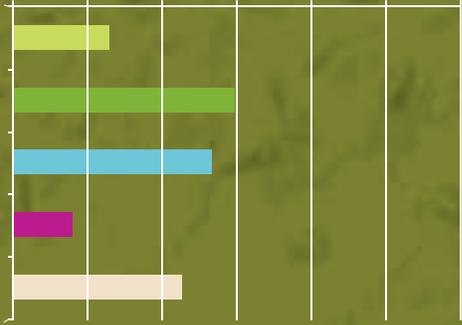
Rio Rico Reach

- Cottonwood Forests & Woodlands
- Mesquite Forests & Woodlands
- Other Vegetation
- Human Infrastructure
- Agriculture & Pasture
